ΑΣΤΟΧΙΕΣ ΣΥΓΚΟΛΛΗΣΕΩΝ

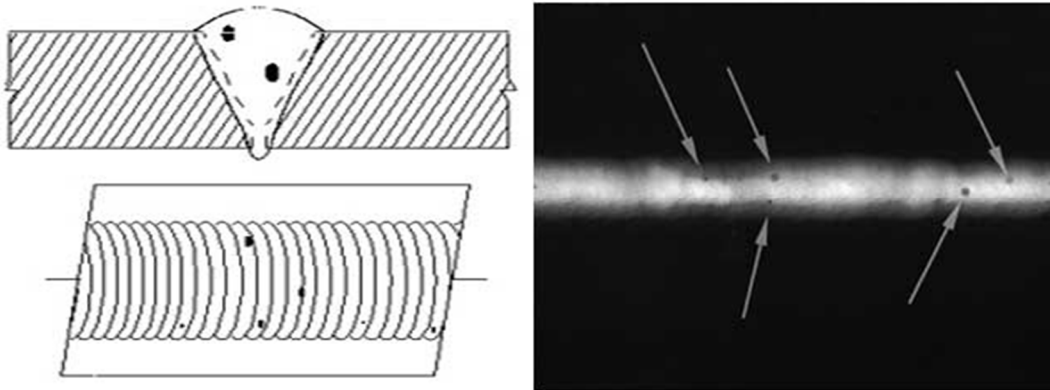
Πορώδες: is the result of gas entrapment in the solidifying metal. Porosity can take many shapes on a radiograph but often appears as dark round or irregular spots or specks appearing singularly, in clusters, or in rows. Sometimes, porosity is elongated and may appear to have a tail. This is the result of gas attempting to escape while the metal is still in a liquid state and is called wormhole porosity. All porosity is a void in the material and it will have a higher radiographic density than the surrounding area.

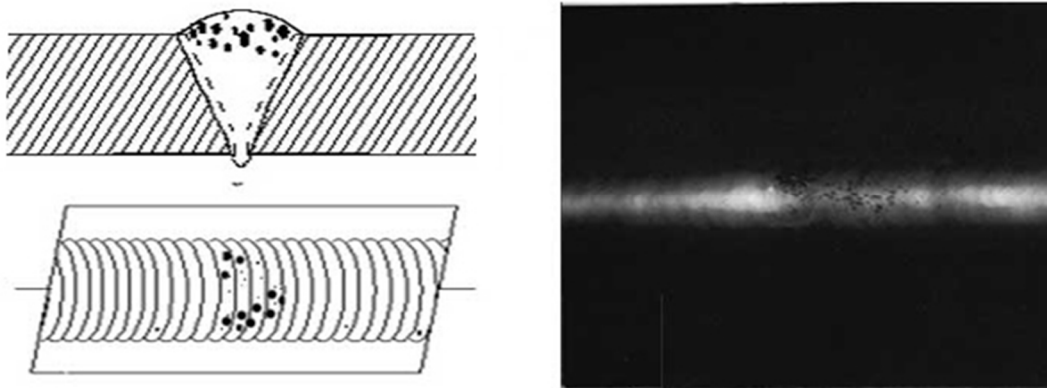
Πορώδες περιοχής: is caused when flux coated electrodes are contaminated with moisture. The moisture turns into a gas when heated and becomes trapped in the weld during the welding process. Cluster porosity appears just like regular porosity in the radiograph but the indications will be grouped close together.

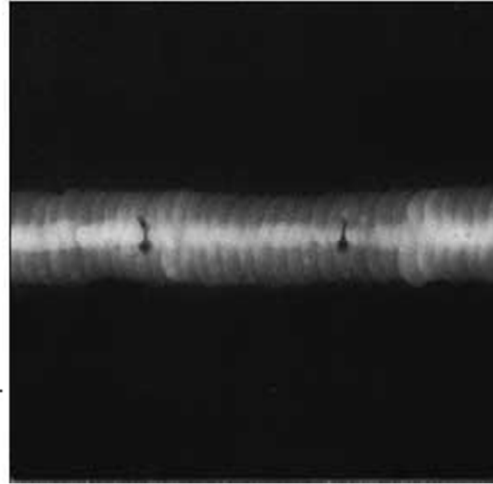
Εγκλείσματα σκουριάς: are nonmetallic solid material entrapped in weld metal or between weld and base metal. In a radiograph, dark, jagged asymmetrical shapes within the weld or along the weld joint areas are indicative of slag inclusions.

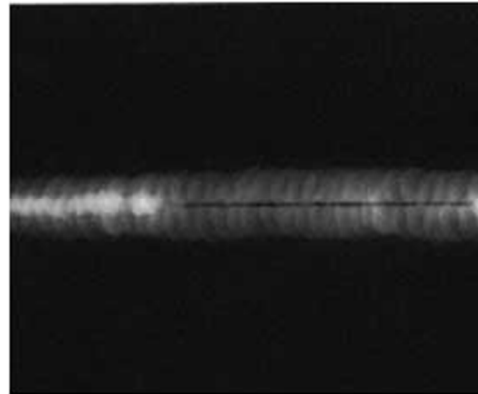
Inadequate or Lack of Penetration

Ατελής διείσδυση: occurs when the weld metal fails to penetrate the joint. It is one of the most objectionable weld discontinuities. Lack of penetration allows a natural stress riser from which a crack may propagate. The appearance on a radiograph is a dark area with well-defined, straight edges that follows the land or root face down the center of the weldment.

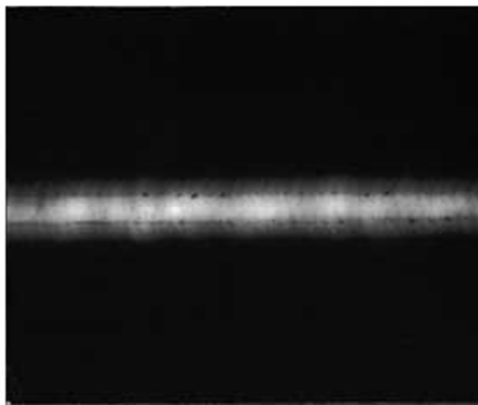
Ατελής τήξη: is a condition where the weld filler metal does not properly fuse with the base metal. Appearance on radiograph: usually appears as a dark line or lines oriented in the direction of the weld seam along the weld preparation or joining area.

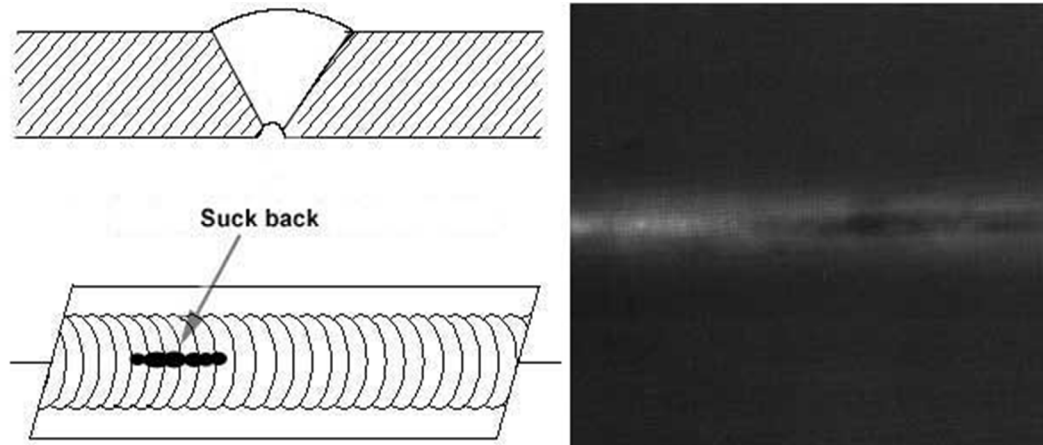
Εσωτερική κοιλότητα: is a condition where the weld metal has contracted as it cools and has been drawn up into the root of the weld. On a radiograph it looks similar to a lack of penetration but the line has irregular edges and it is often quite wide in the center of the weld image.

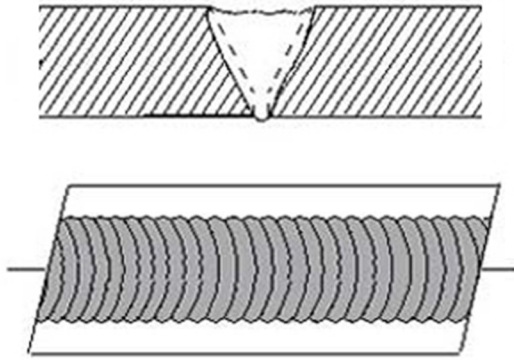
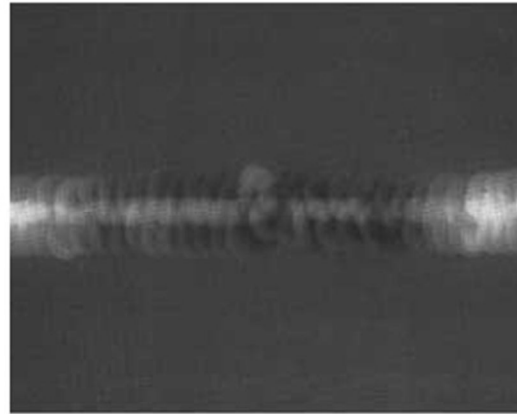
Υποσκαφή: is an area of a weld where the thickness of weld metal deposited is less than the thickness of the base material. It is very easy to determine by radiograph if the weld has inadequate reinforcement, because the image density in the area of suspected inadequacy will be higher (darker) than the image density of the surrounding base material.

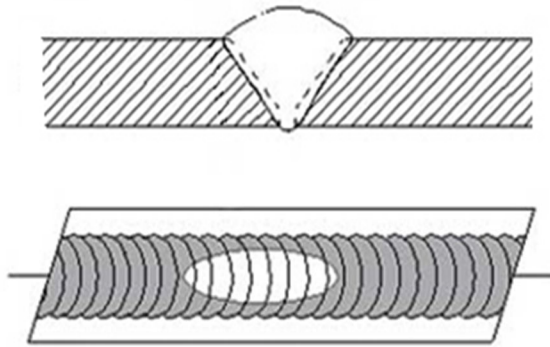
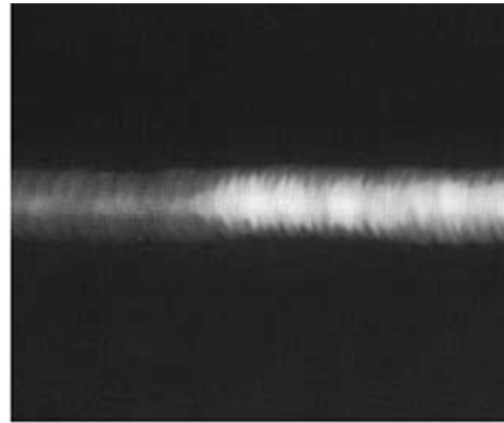
Επικόλυψη: is an area of a weld that has weld metal added in excess of that specified by engineering drawings and codes. The appearance on a radiograph is a localized, lighter area in the weld. A visual inspection will easily determine if the weld reinforcement is in excess of that specified by the engineering requirements.

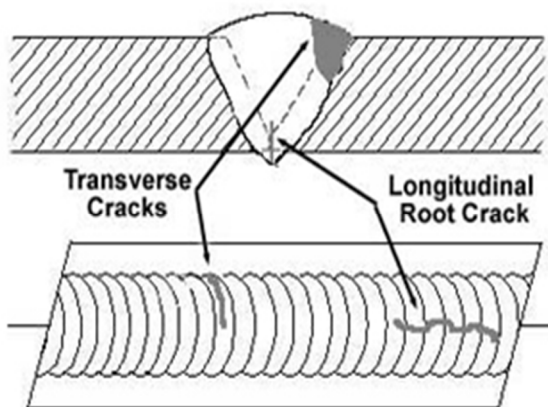
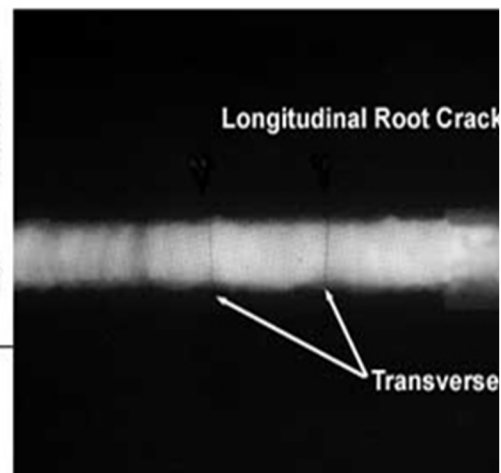
Ρωγμές: can be detected in a radiograph only when they are propagating in a direction that produces a change in thickness that is parallel to the x-ray beam. Cracks will appear as jagged and often very faint irregular lines. Cracks can sometimes appear as "tails" on inclusions or porosity.
